# Manhole Inspection Summary

Manhole # S53M\_\_039MH

**Location** Address: **behind 3208 Alley Dillon ODonnell** Cross Street: **S East Bouldin**

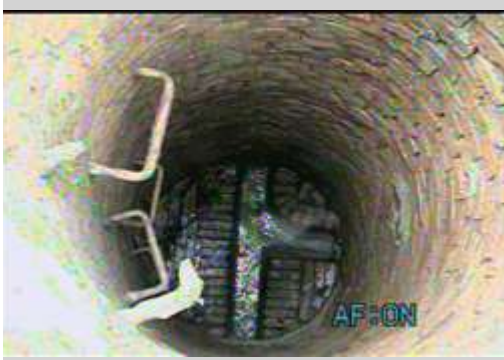
Defect 1

**Steps** Count: **7** Missing: **1** ☒ **Corroded**

corroded stairs, bench debris

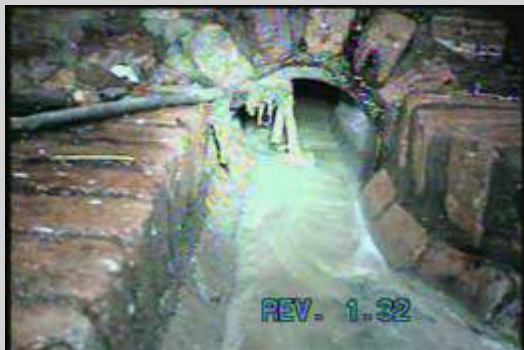
12 O'Clock Outflow

8 in. Circular Gravity Sewer  
Pipe Out @ 12 O'Clock

Pipe Material: **Clay** ☐ Pipe Lined

Invert Depth: **12.09** (ft.) Flow Characteristics: **Fast**

Infiltration: **None** Pipe Seal Cond: **Unknown**

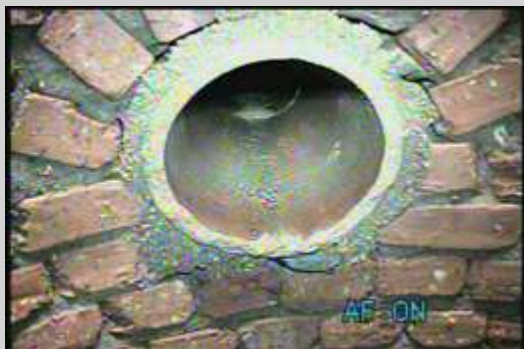
3 O'Clock Inflow

8 in. Circular Gravity Sewer  
Pipe In @ 3 O'Clock

Drop In @ 3 O'Clock

Invert Depth: **6.70** (ft.) Flow Characteristics: **Fast**

Drop: **Outside Direct**

Drop Condition: **Open**

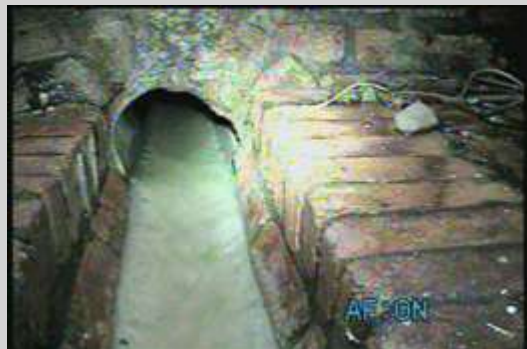
6 O'Clock Inflow

8 in. Circular Gravity Sewer  
Pipe In @ 6 O'Clock

Pipe Material: **Clay** ☐ Pipe Lined

Invert Depth: 11.61 (ft.) Flow Characteristics: **Fast**

Infiltration: **None** Pipe Seal Cond: **Unknown**
